Deception Pass Log Rail

Submitted for presentation at the 84th Annual Meeting of the Transportation Research Board, Washington D.C.
2005.

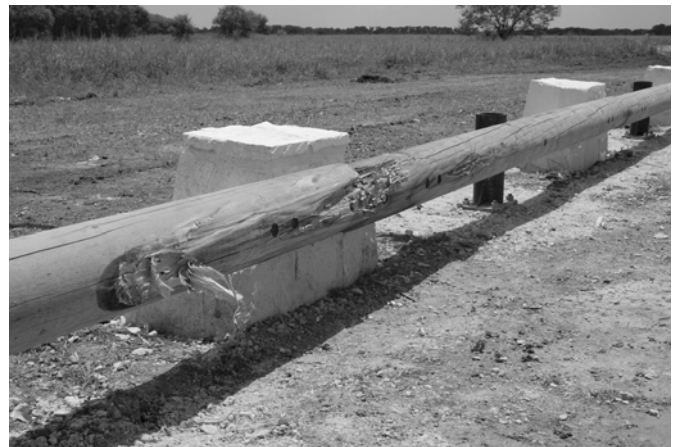
FIGURE 4 Barrier damage from test 400561-1.

Damage to the log rail was primarily to the timber log element, as shown in Figure 4. The log element was gouged to a maximum depth of 0.8" near bollard 5. Tire marks extended 3.5" under the log element just downstream of the splice at bollard 5. Bollard 5 was pushed toward the field side 0.4". The vehicle was in contact with the log element for 11.5'. Maximum dynamic deflection was not measurable.

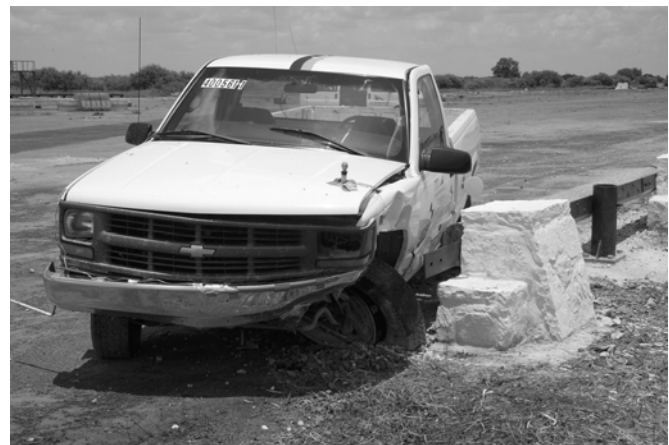
FIGURE 5 Vehicle damage from test 400561-1.

The left front quarter of the pickup truck sustained most of the damage, as shown in Figure 5. Structural damage was imparted to the left upper and lower A-arm, left outer tie rod, and left frame rail. Also damaged were the front bumper, grill, left front quarter panel, left front tire and wheel rim, left door, and left rear wheel rim. Maximum exterior crush to the vehicle was 25.0" in the frontal plane at the left front corner near bumper height. Maximum occupant compartment deformation was 2.3" in the center front floorpan over the transmission tunnel

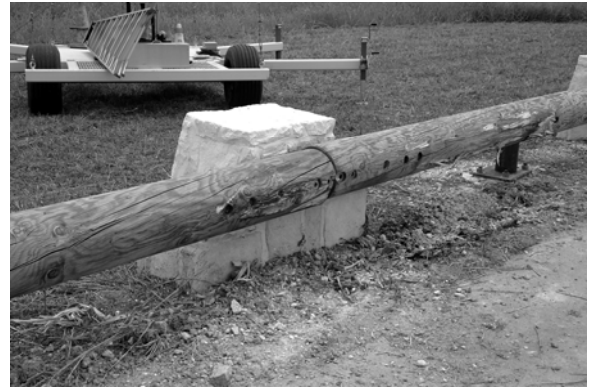
FIGURE 6 Barrier damage from test 400561-

Damage to the log rail was primarily to the timber log element, as shown in Figure 6. The log element was gouged and tire marks extended along the face of the log. Bollard 6 was disturbed only. The vehicle was in contact with the log element 12.5 ft. Maximum dynamic deflection was not measurable.

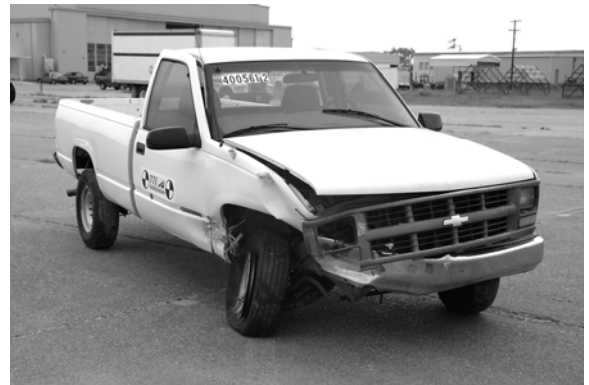
FIGURE 7 Vehicle damage from test 400561-

The right front quarter of the pickup truck sustained most of the damage, as shown in Figure 7. Structural damage was imparted to the right upper A-arm, right side floor pan, and right frame rail. Also damaged were the front bumper, grill, right front quarter panel, right front tire and wheel rim, and right door. Maximum exterior crush to the vehicle was 23.6“ in the frontal plane at the left front corner near bumper height. Maximum occupant compartment deformation was 2.5” in the center front floor pan over the transmission tunnel.

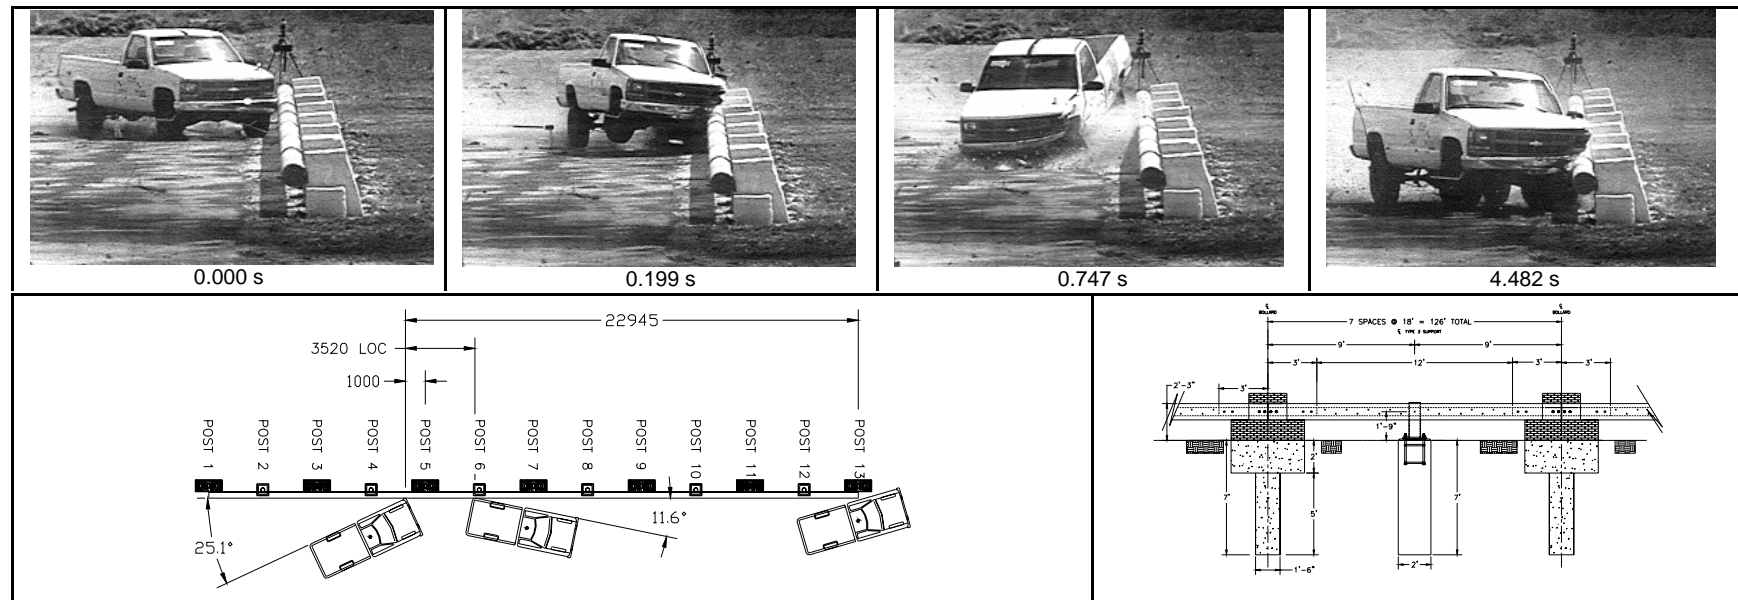
FIGURE 9 Summary of test results – Test 400561-1.

This test met all of the evaluation criteria in NCHRP Report 350. A summary of the test information is shown on Figure 9.
